**2012 Annual Inspection Report**

**BRADY CANAL HYDROLOGIC  
RESTORATION PROJECT (TE-28)**

State Project Number TE-28  
Priority Project List 3

July 15, 2012  
Terrebonne Parish

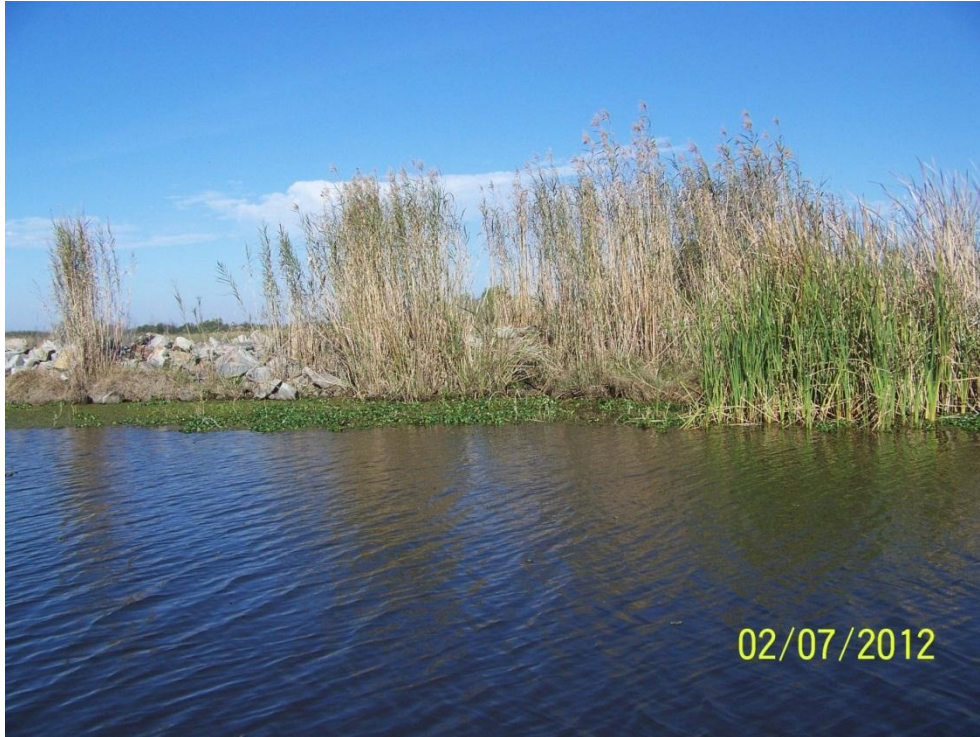
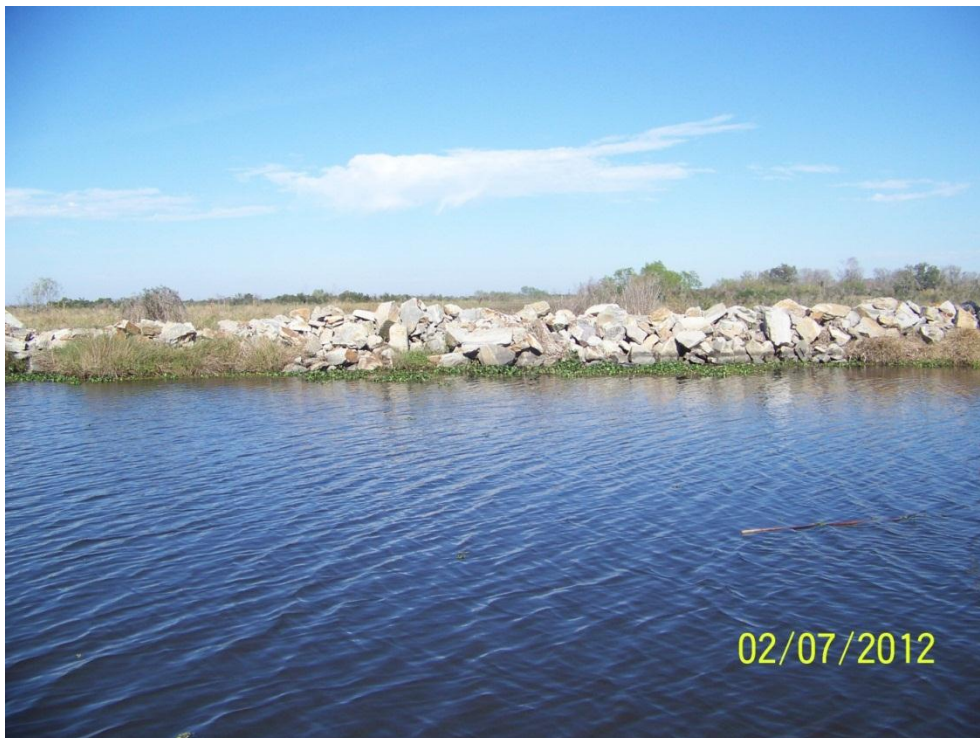
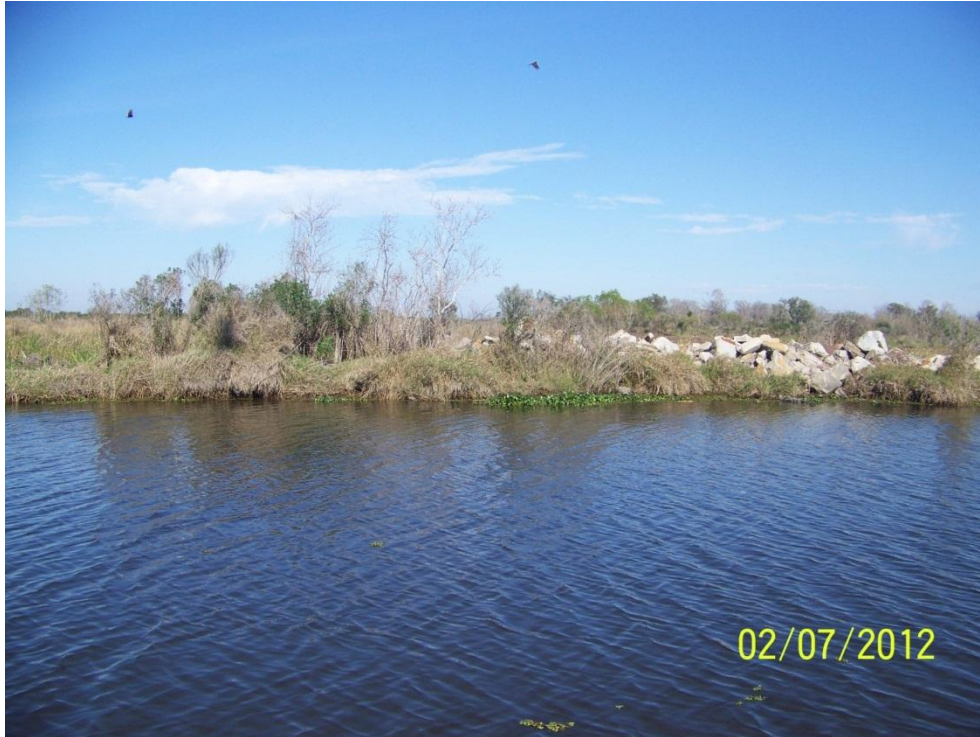
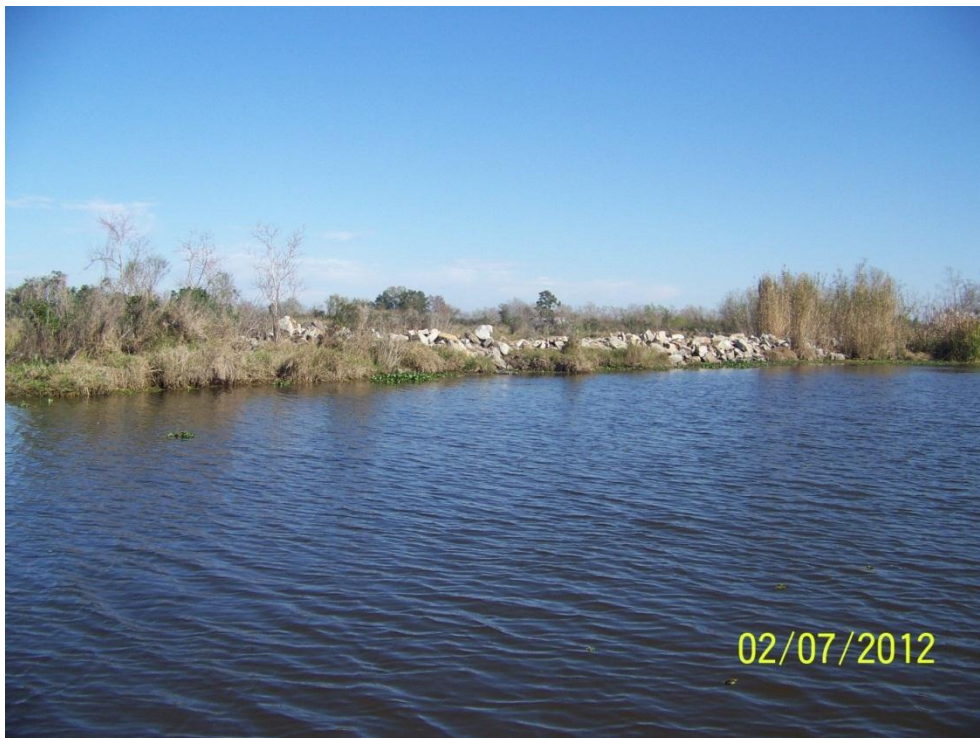
Breach 7 located along the oil field access canal connecting to Superior canal is in good overall condition. There is no observed settlement along the length of the embankment and no erosion or washouts around the embankment tie-ins. There are no recommendations for corrective action at this time, but it will continue to be monitored on future inspections. (See Appendix B, Photos 1 through 4)

Photo #1: Breach 7 located in an oilfield access canal off of Superior Canal. View of northeast embankment tie-in obscured by vegetation.

Photo #2: Breach 7 located in an oilfield access canal off of Superior Canal. No visible settlement or displacement of rock fill material.

Photo #3: Breach 7 located in an oilfield access canal off of Superior Canal. View of southwest embankment tie-in obscured by vegetation.

Photo #4: Breach 7 located in an oilfield access canal off of Superior Canal. An overall view of the breach looking north from canal.

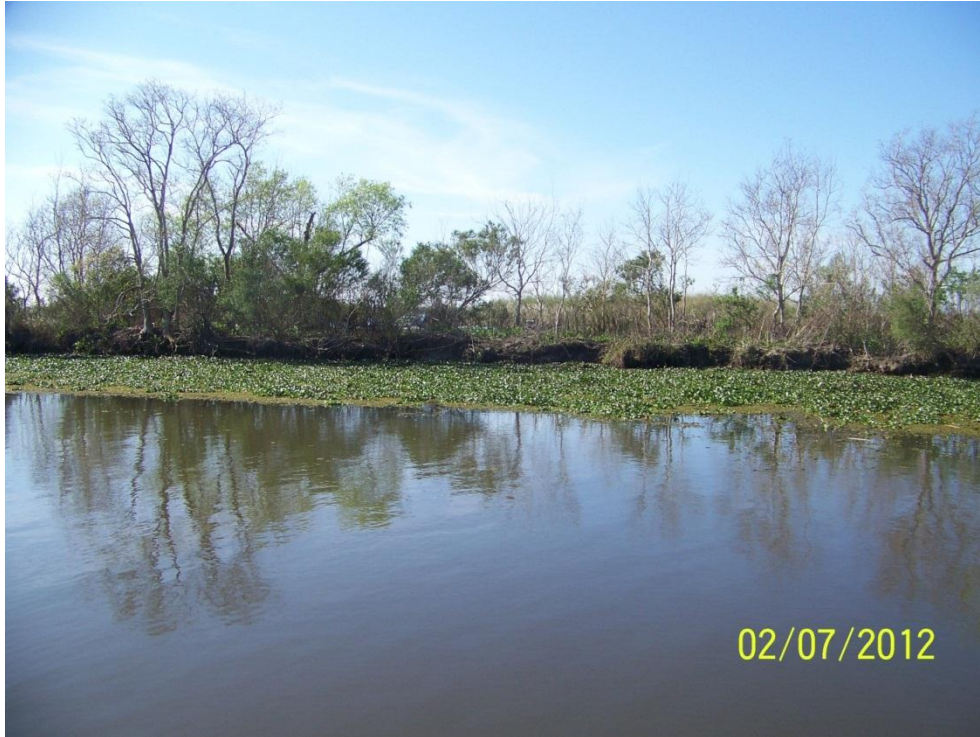
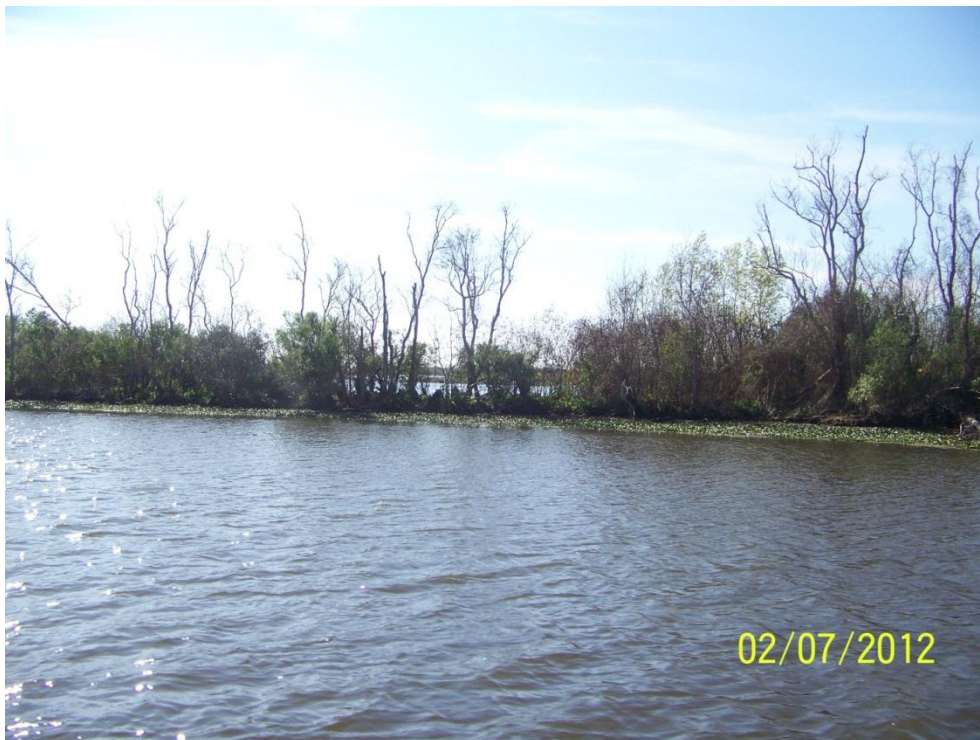
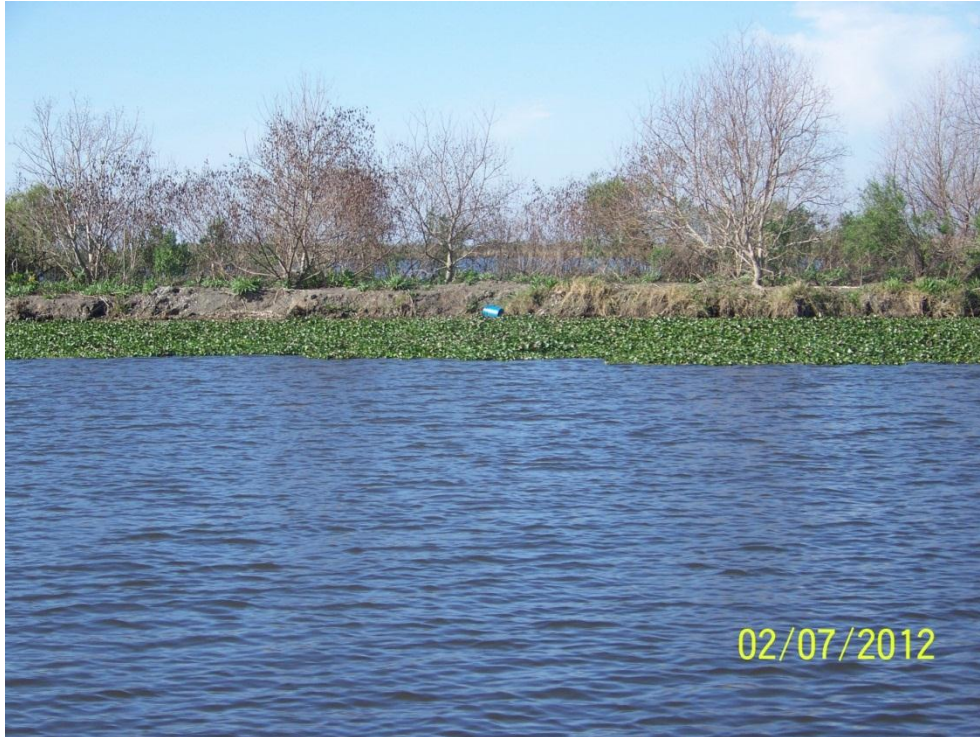
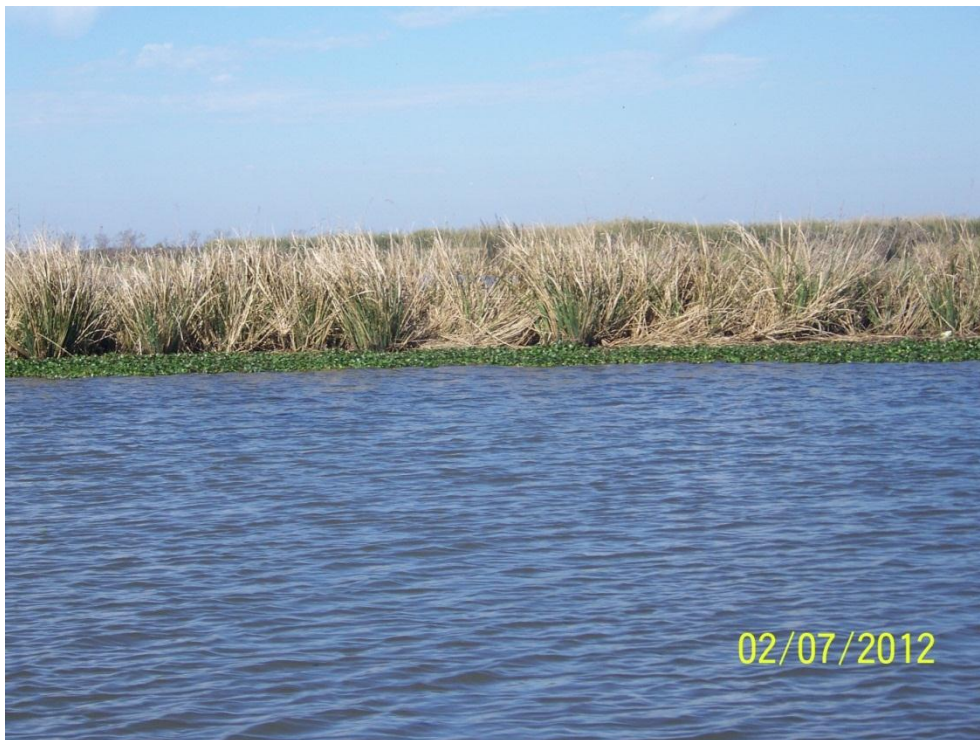
The inspection of the earthen embankments progressed from Superior Canal, Turtle Bayou, Bayou Decade, through Voss Canal, Bayou Carencro, and concluded along Brady Canal. All of the earthen banks along Superior Canal and Turtle Bayou are in good condition, there is

some variance in elevation and vegetative growth but no breaches or cut banks were observed during the inspection (See Appendix B, Photos 5 through 8). The earthen embankments along Bayou Decade and Voss Canal are also in good condition. These areas have seen some erosion but little to no change since the previous inspections. There is little threat of these areas breaching, therefore they have been omitted from the 2012 Maintenance Project (See Appendix B, Photo 41 and Photos 48 through 49).

Photo #5: Earthen embankment along Superior Canal. View of embankment looking southwest from Superior Canal.

Photo #6: Earthen embankment along Superior Canal. View of embankment looking southwest from Superior Canal.

Photo #7: Earthen embankment along Turtle Bayou. View of embankment looking northwest from Turtle Bayou.

Photo #8: Earthen embankment along Turtle Bayou. View of embankment looking northwest from Turtle Bayou.

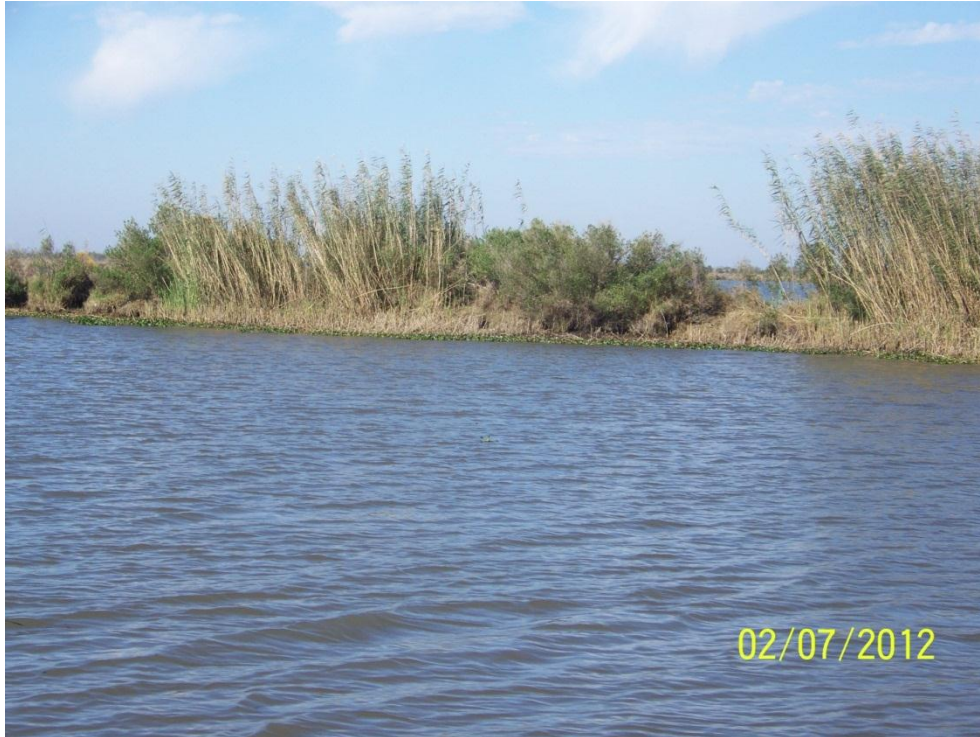
Photo #9: Earthen embankment along Bayou Decade. View of embankment looking north from Bayou Decade.

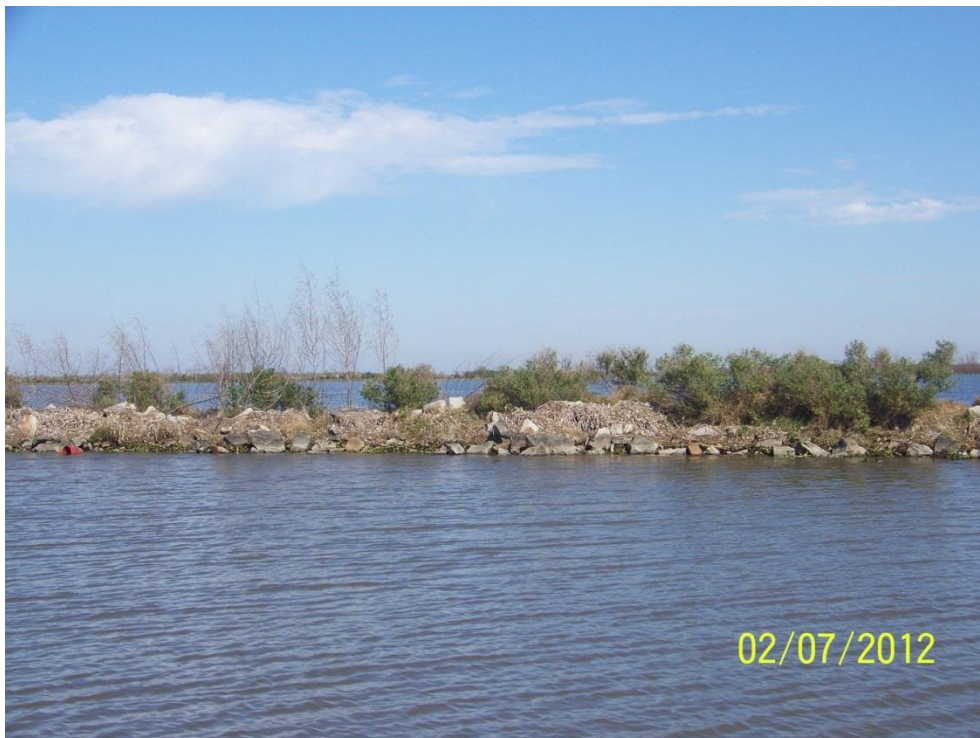
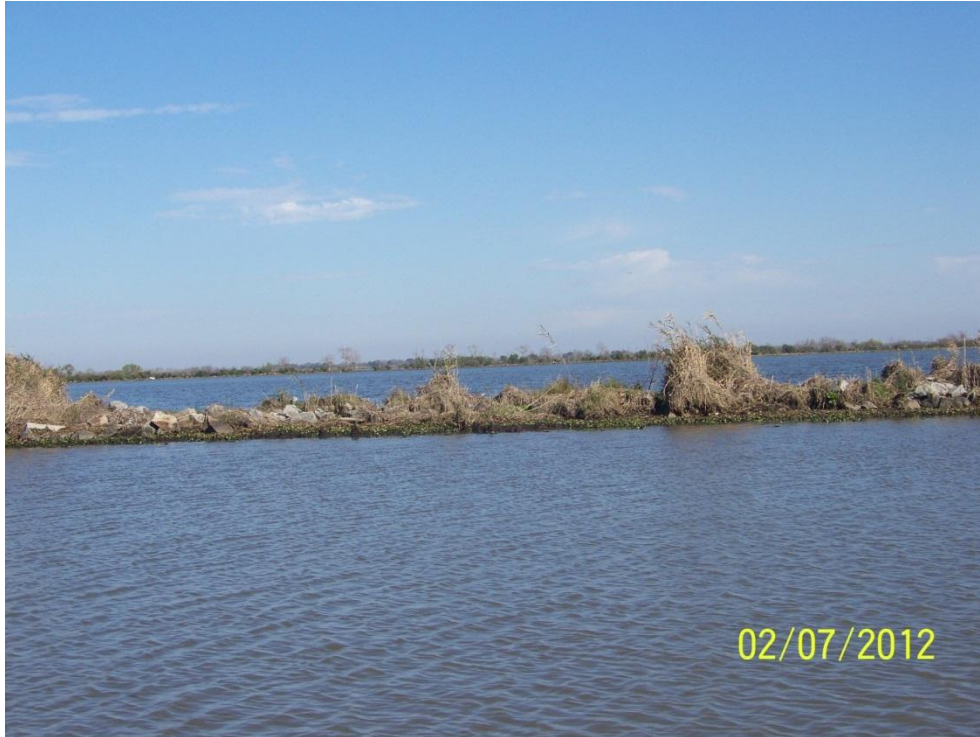
The rock armored embankments and rock dikes found along the north bank of Bayou Decade and Voss Canal are in good condition. The earthen embankment with rock revetment beginning at the intersection of Bayou Decade and Voss Canal had some initial settlement after construction but has experienced little change since previous inspections. The earthen embankment with rock revetment west of structure 7 along Bayou Decade appears to be in good condition with no apparent settlement. The rock dike along Bayou Decade between Jug Lake and Turtle Bayou appears to be in fair condition with isolated low areas and moderate displacement. Despite some minor deficiencies, the structures appear to be operating as intended, therefore there will be no repairs included in the 2012 Maintenance Project. (See Appendix B, Photos 10 through 11, Photo 39, Photos 42 through 43)

Photo #10: View of Bayou Decade Rock Dike looking north. There was no observed settlement of the rock dike from previous years.

Photo #11: View of Bayou Decade Rock Dike looking north. There was no observed settlement of the rock dike from previous years.

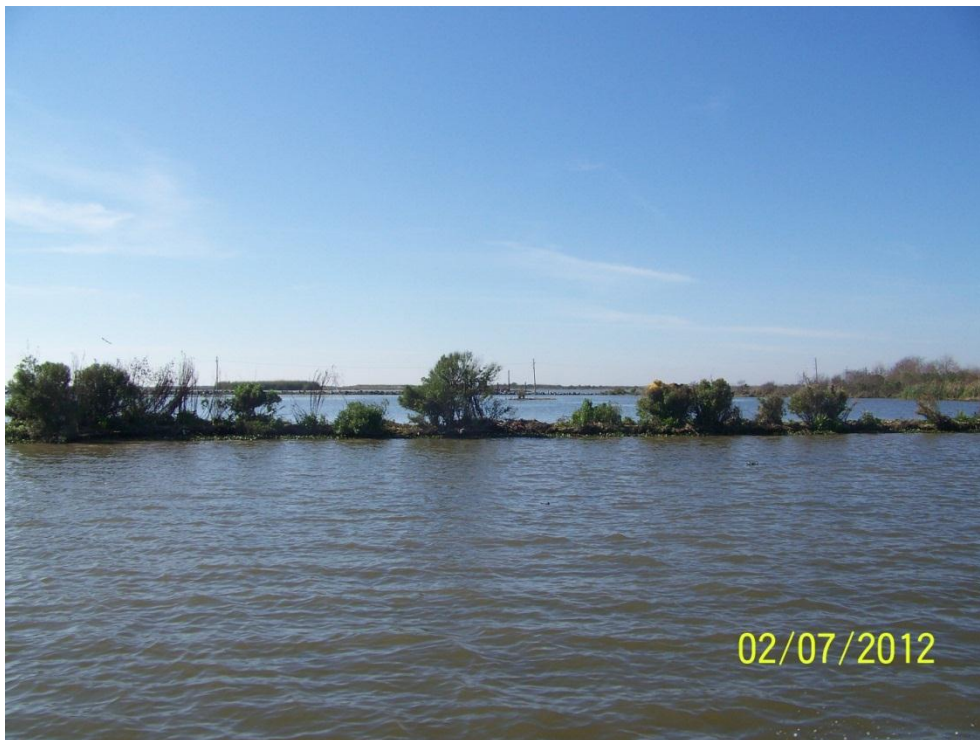
The Jug Lake lake rim is the area of most concern throughout the entire project. Over the last several years the earthen rim has been subjected to strong storm systems, hurricanes Katrina, Rita, Gustav, and Ike, which have deteriorated the lake rim to a narrow barrier with several breaches. In addition to the hurricanes, there is very little marsh in the project area, thus exposing the thin barrier to high wave energies from both Jug Lake and the open water of the project area. The complete failure of this lake rim would be extremely detrimental to the project area as it renders three (3) water control structures ineffective and would allow large amounts of high saline water into an area that is predominantly brackish. The most critical areas of the lake rim have been selected to be refurbished in the 2012 Maintenance Project. Borrow material from the lake will be used to rebuild these areas.

Photo #12: Southeast lake rim, view from Jug Lake looking southeast. This area has substantial deterioration and is scheduled to be rebuilt in the 2012 maintenance event.

The refurbishment of the lake rim shall include clearing and grubbing trees and brush along 13,900 linear feet of the existing rim and excavating material from the lake bottom to restore the rim to the original designed section, followed by seeding of approximately 20 acres of the repaired lake rim. Due to budget restraints, only the areas of most concern along the lake rim were chosen to be refurbished, and these areas can be seen in Appendix D, 2012 Work Plan.

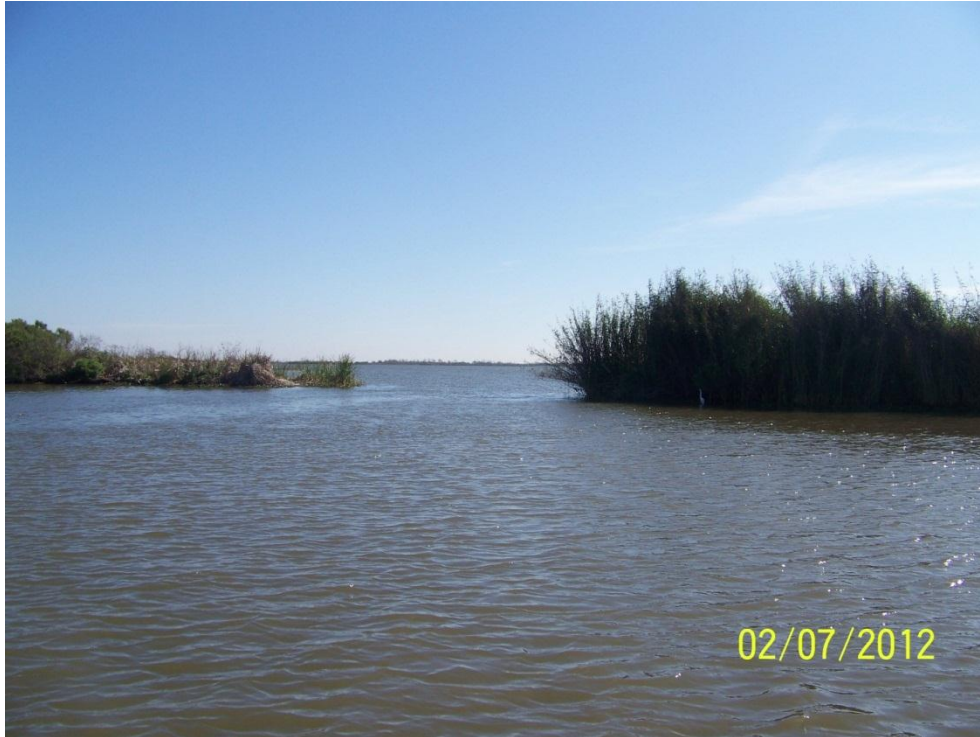
Photo #13: Large Breach located in southeast lake rim, view looking east from Jug Lake. It is a pre-existing breach approximately 40 feet wide to be repaired in 2012 maintenance event.

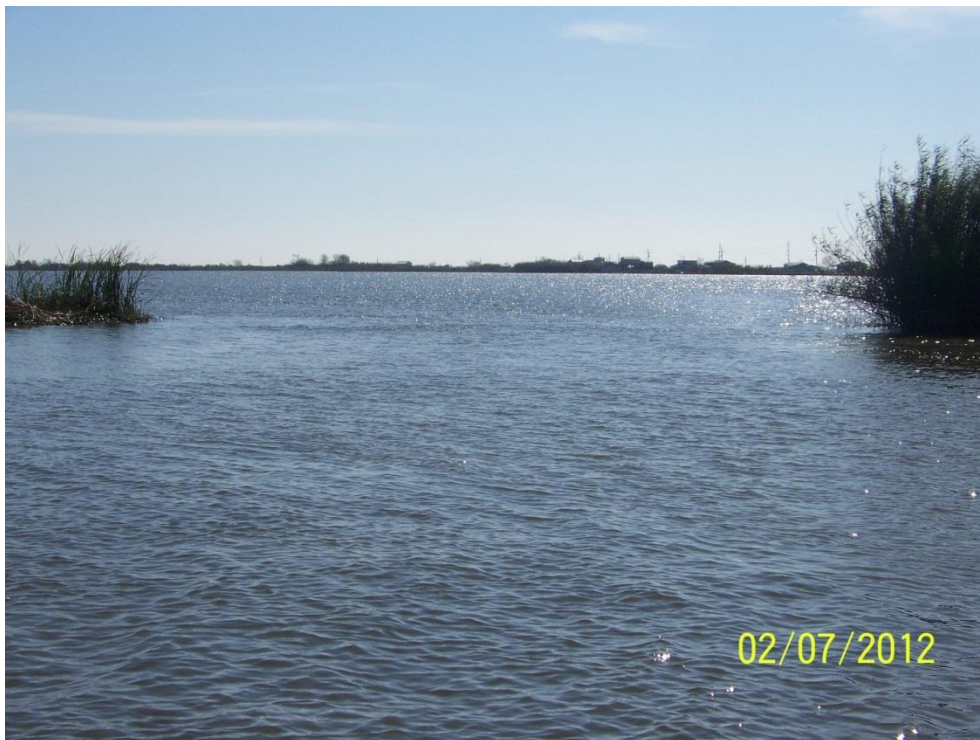
Photo #14: Large Breach located in southeast lake rim, view looking southeast from Jug Lake. It is a pre-existing breach approximately 40 feet wide to be repaired in 2012 maintenance event.

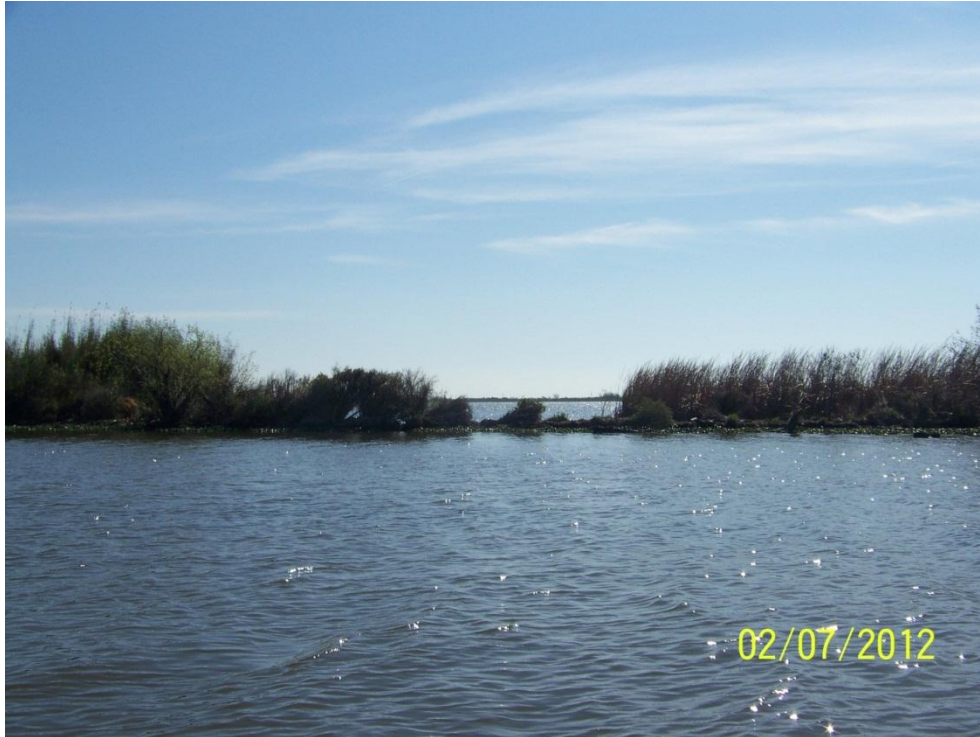
Photo #15: Low area in the southeast lake rim, view looking southeast from Jug Lake.

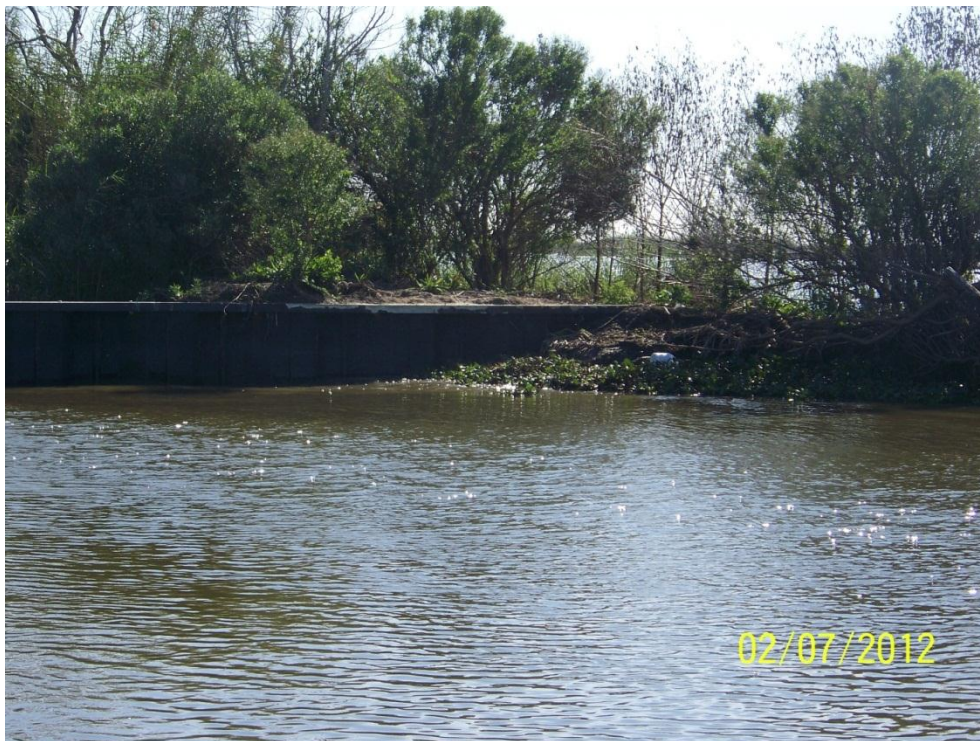
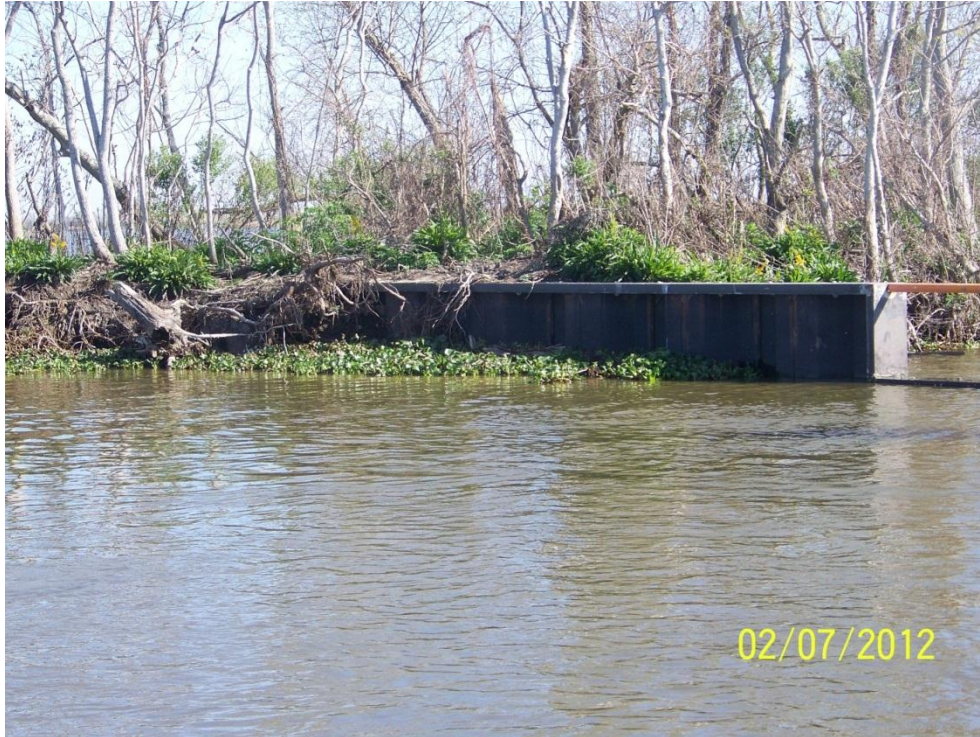
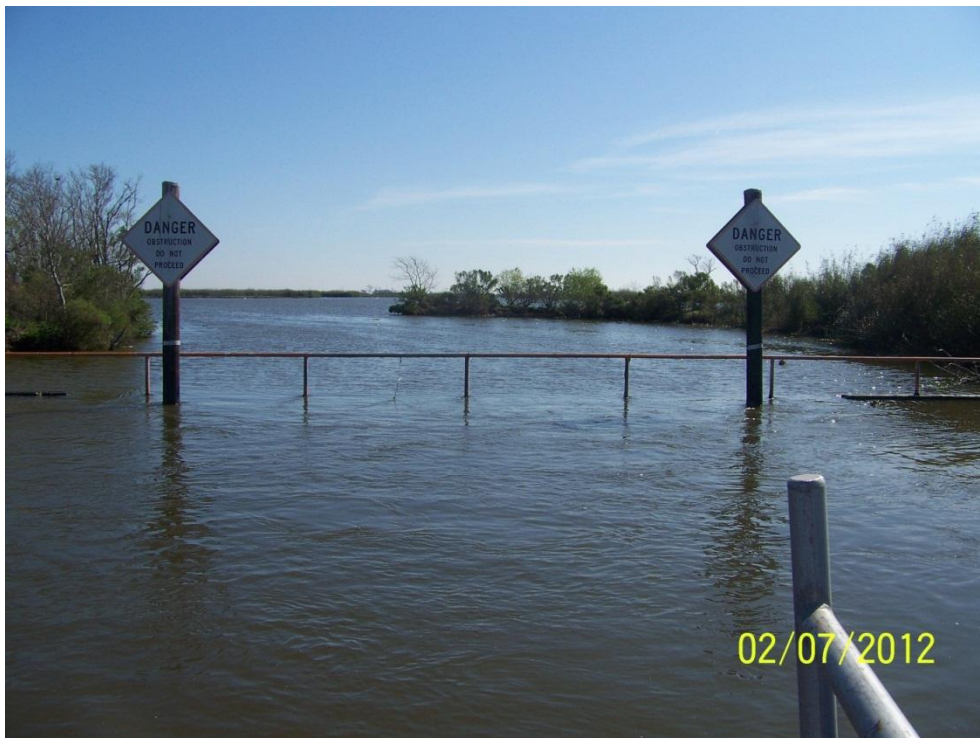
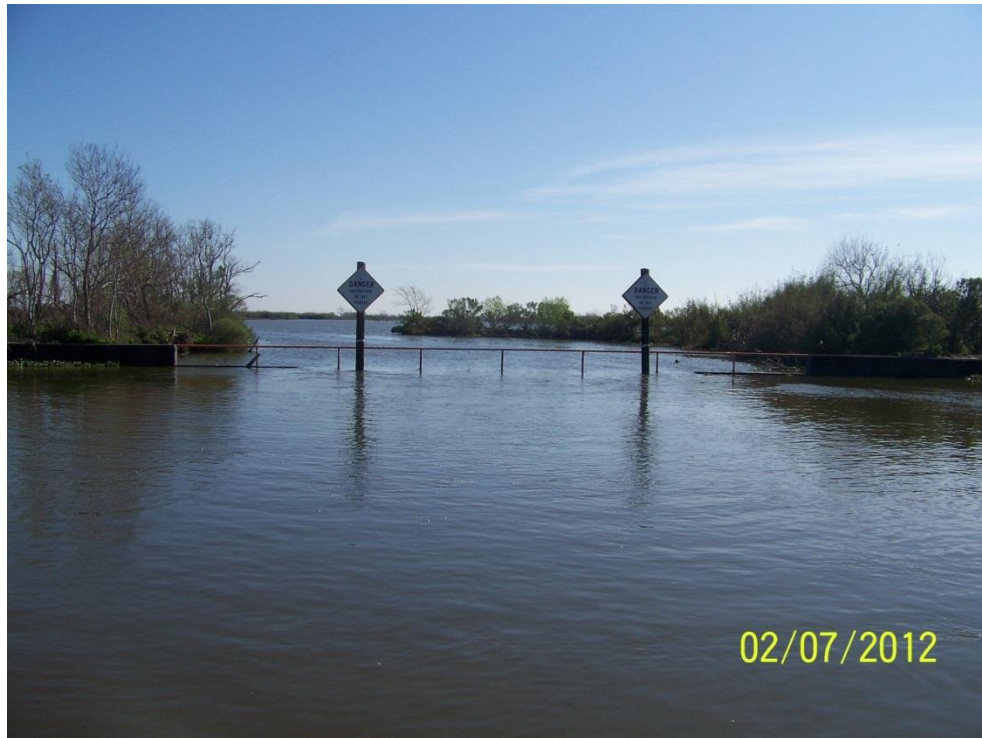
Structure 24 is in good overall condition. The warning signs, timbers, railings and steel bulkhead show no signs of damage. The earthen embankment tie-ins are intact and holding well since their refurbishment in 2007. Although repairs are not immediately needed, past experience shows the tie-ins are vulnerable to erosion. Therefore, rock armoring of the tie-ins is included as an alternate in the 2012 Maintenance Project as a preemptive action to protect the structure. (See Appendix B, Photos 16 through 19)

Photo #16: View of Structure 24 from Jug Lake looking east. The southern embankment tie-in of structure 24 is in good overall condition.

Photo #17: View of Structure 24 from Jug Lake looking east. The northern embankment tie-in of structure 24 is also in good overall condition.

Photo #18: View of Structure 24 from Jug Lake looking east. Close up of the warning signs, support timbers, and barricades on the structure.

Photo #19: An overall view of Structure 24 from Jug Lake looking east.

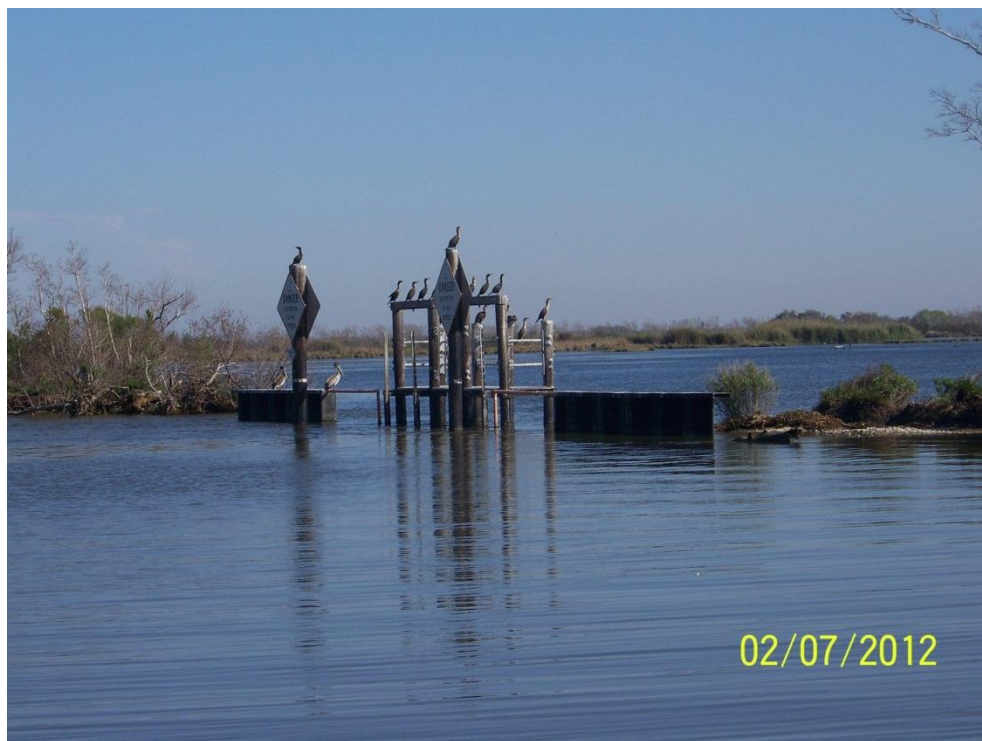
This structure is also in fair condition. There is no visible damage to the steel bulkhead, railings, platform, or the warning signs and their support timbers. However, there are large breaches on both of the earthen embankment tie-ins. The north tie-in has been repaired several times, so to prevent further damage, the earthen embankment tie-ins are to be rebuilt and armored with rock rip rap for 50' in both directions. These repairs are included in the 2012 Maintenance Project. (See Appendix B, Photos 20 through 24)

Photo #20: An overall view of Structure 23 from Jug Lake looking northeast. Structure 23 has experienced erosion around both its embankment tie-ins.

The variable crest weir structures along the rim of Jug Lake will have their earthen embankment tie-ins refurbished during the 2012 Maintenance Project. This will consist of utilizing fill material from the lake bed to rebuild their tie-ins to the original design specifications. In addition to the earthen embankments, it is recommended that the tie-ins be armored with rock riprap 50 linear feet in both directions to prevent further erosion and breaches. Due to the high cost of rock riprap placement, the armoring of Structure 23, which has a history of breaches and is in the worst condition of the three weirs, has been included in the base bid of the 2012 Maintenance Project. The armoring of Structures 21 and 24 have been included in the project as Alternate Bids #1 and #2 respectively, as these have experienced less erosion and will be armored with rock riprap if the budget allows.

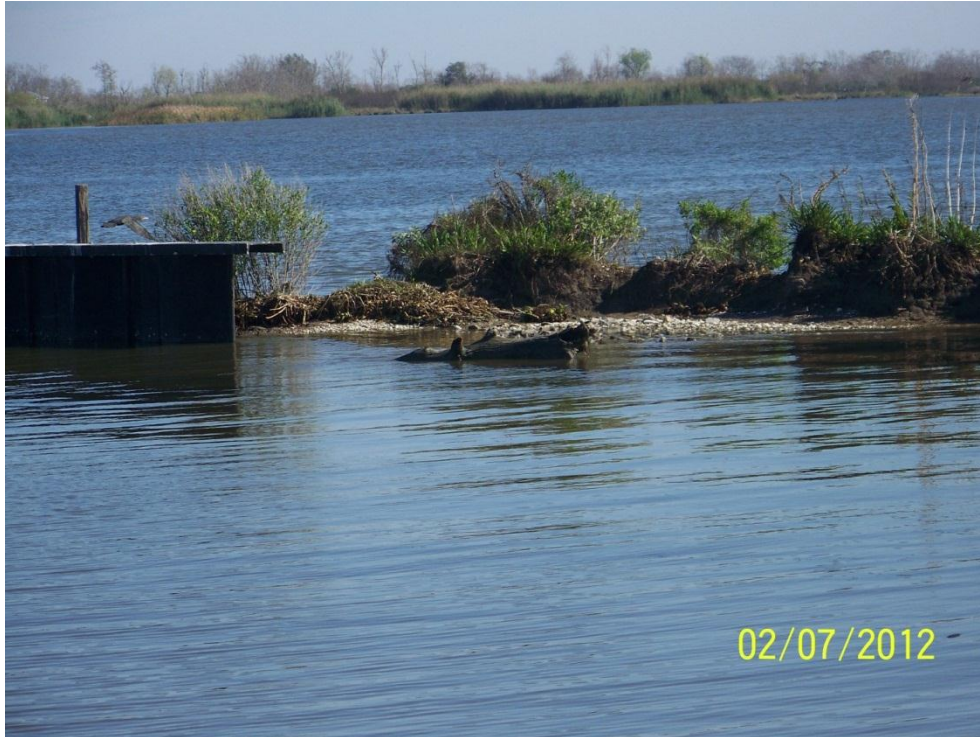
Photo #21: South embankment tie-in of structure 23 looking east. To be reconstructed and rock armored in the 2012 maintenance event.

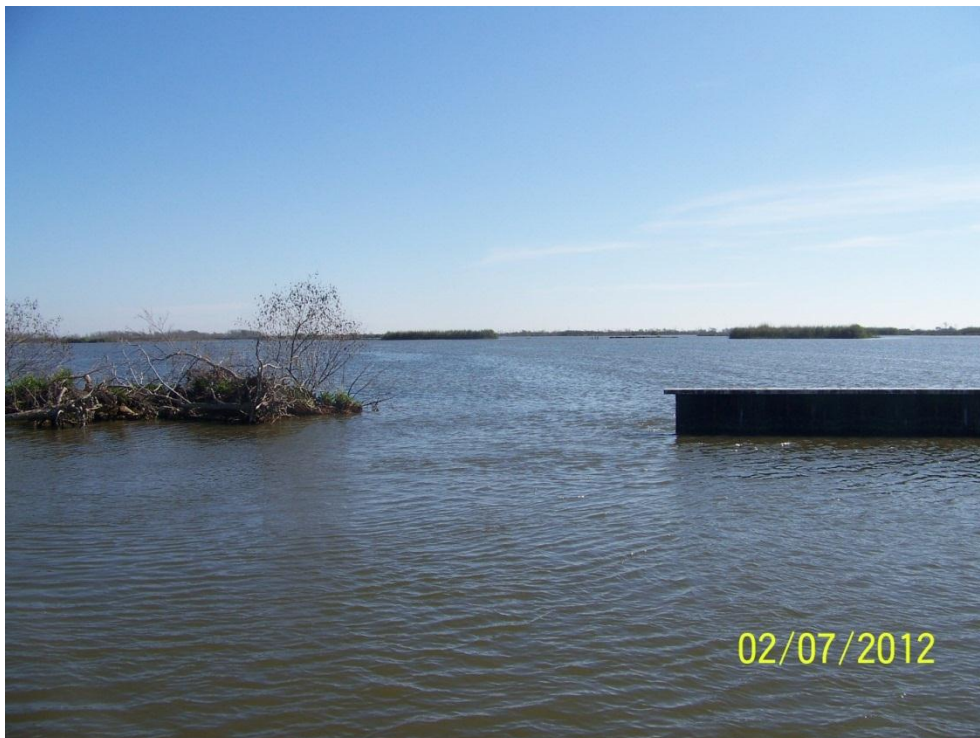
Photo #22: North embankment tie-in of structure 23 looking east. To be reconstructed and rock armored in the 2012 maintenance event.

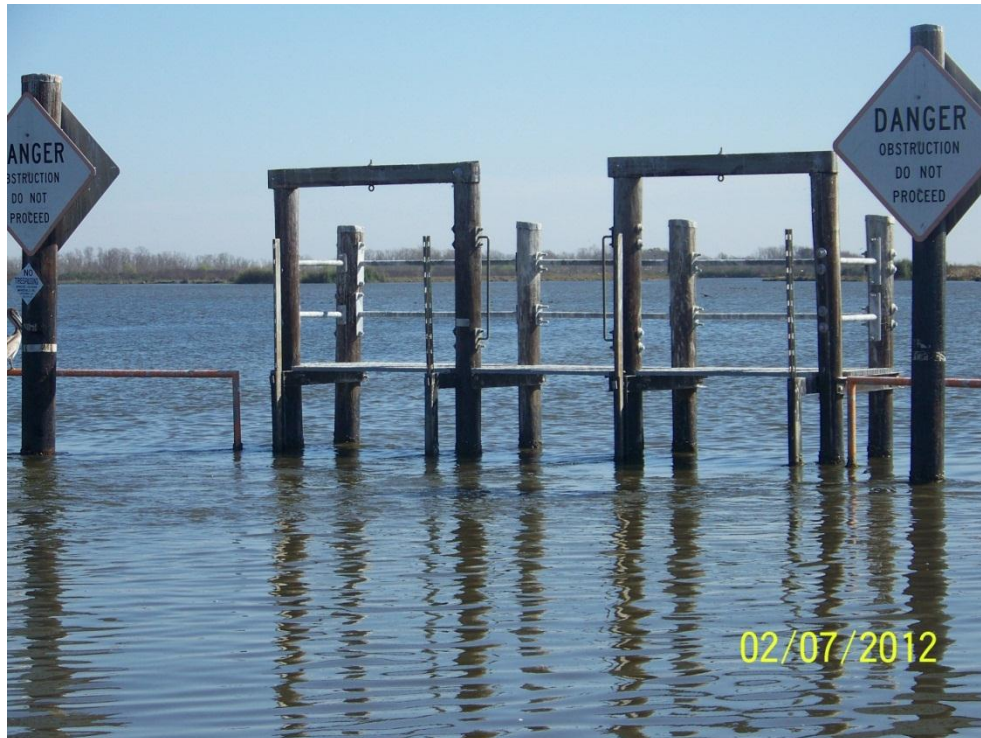
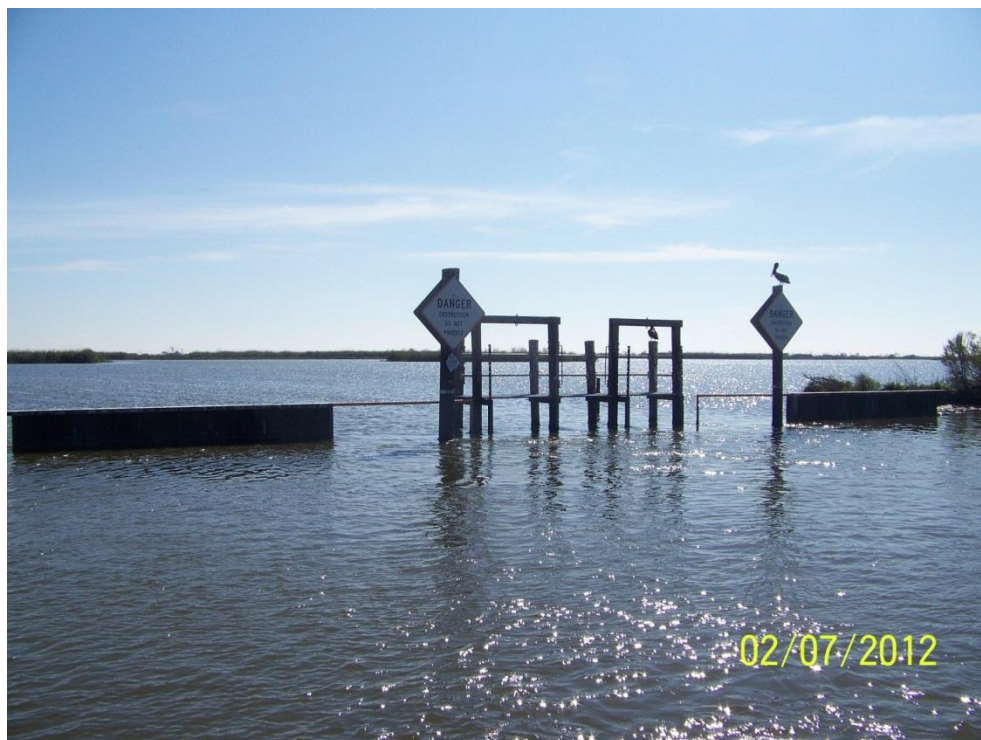
Photo #23: Close up view of the warning signs, support timbers, barricades, and railings of Structure 23, looking east from Jug Lake.

Photo #24: An overall view of Structure 23 from Jug Lake looking southeast.

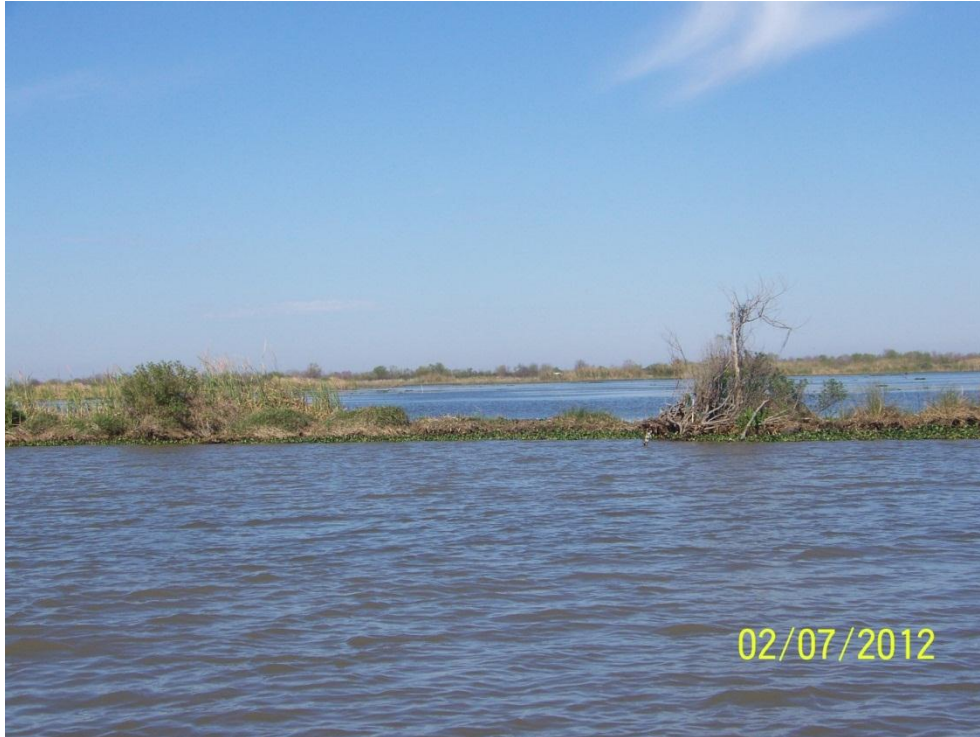
Photo #25: Low section along the northeast lake rim between structure 23 and structure 21, view looking northeast from Jug Lake.

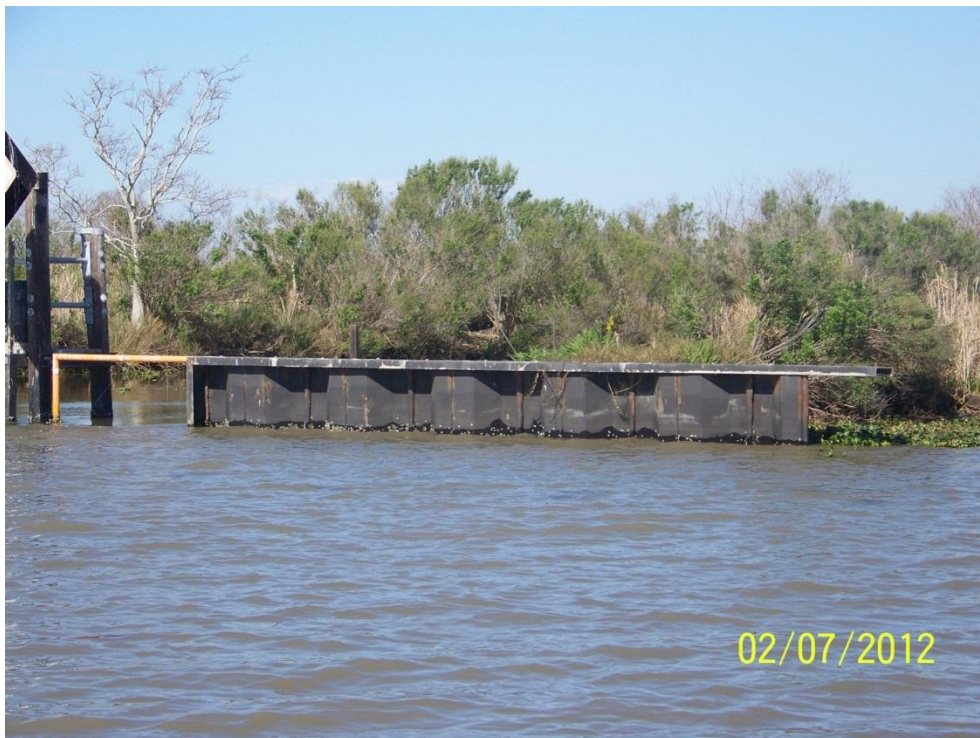
Structure 21 is in fair condition. There is no visible damage to the steel bulkhead, railings, platform, or the warning signs and their support timbers. As reported in previous inspection annual reports, there is substantial erosion of the earthen embankment tie-ins. The steel bulkheads on both sides of the structure are exposed and a breach has formed on the northeast side of the structure. These earthen embankments are to be rebuilt in the 2012 Maintenance Project to repair the damage that has been done and to resume the effectiveness of the structure. (See Appendix B, Photos 26 through 28)

Photo #26: Embankment tie-in on northeast side of Structure 21 has been breached and allows water to flow around the structure, view looking north from Jug Lake.

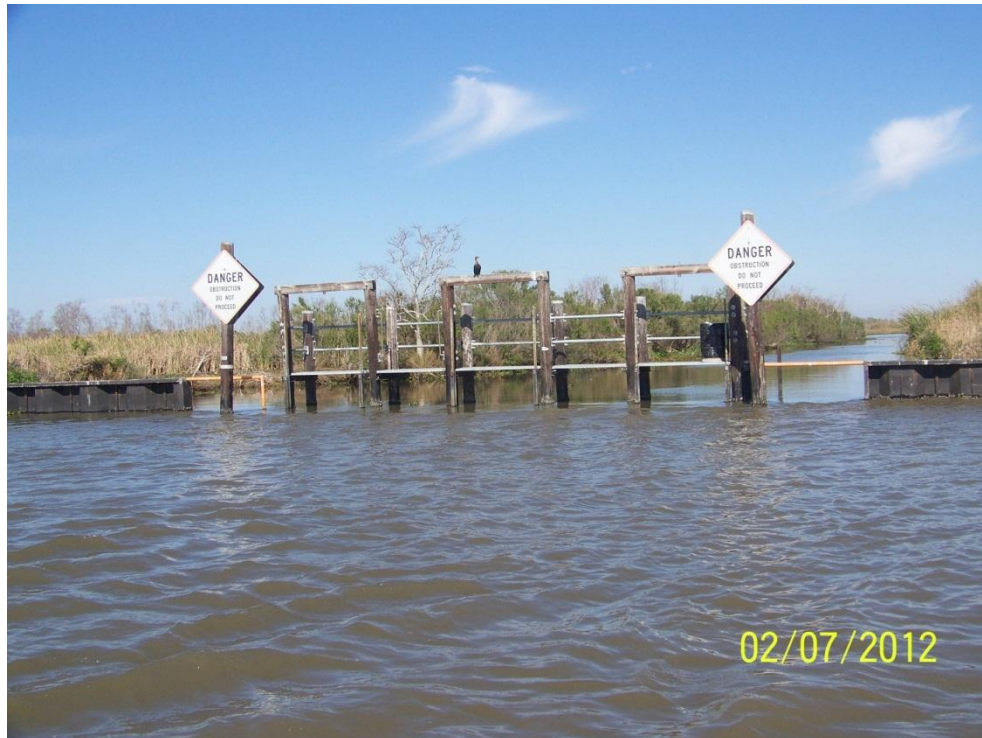
Photo #27: An overall view of Structure 21 looking north from Jug Lake. Embankment tie-ins to be reconstructed during the 2012 maintenance event.
